## Council Sewage Spill Notification Form to the PHS (Block A)

<b>Notifier</b>	Graeme Fox	<b>TLA</b>	Tasman District Council
<b>Date Notified</b>	30 <sup>th</sup> July 2020	<b>Time Notified</b>	11:30
<b>Date of Spill</b>	29 <sup>th</sup> July 2020	<b>Time discovered</b>	11:30
<b>Phone</b> 📞		<b>Phone</b> 📱

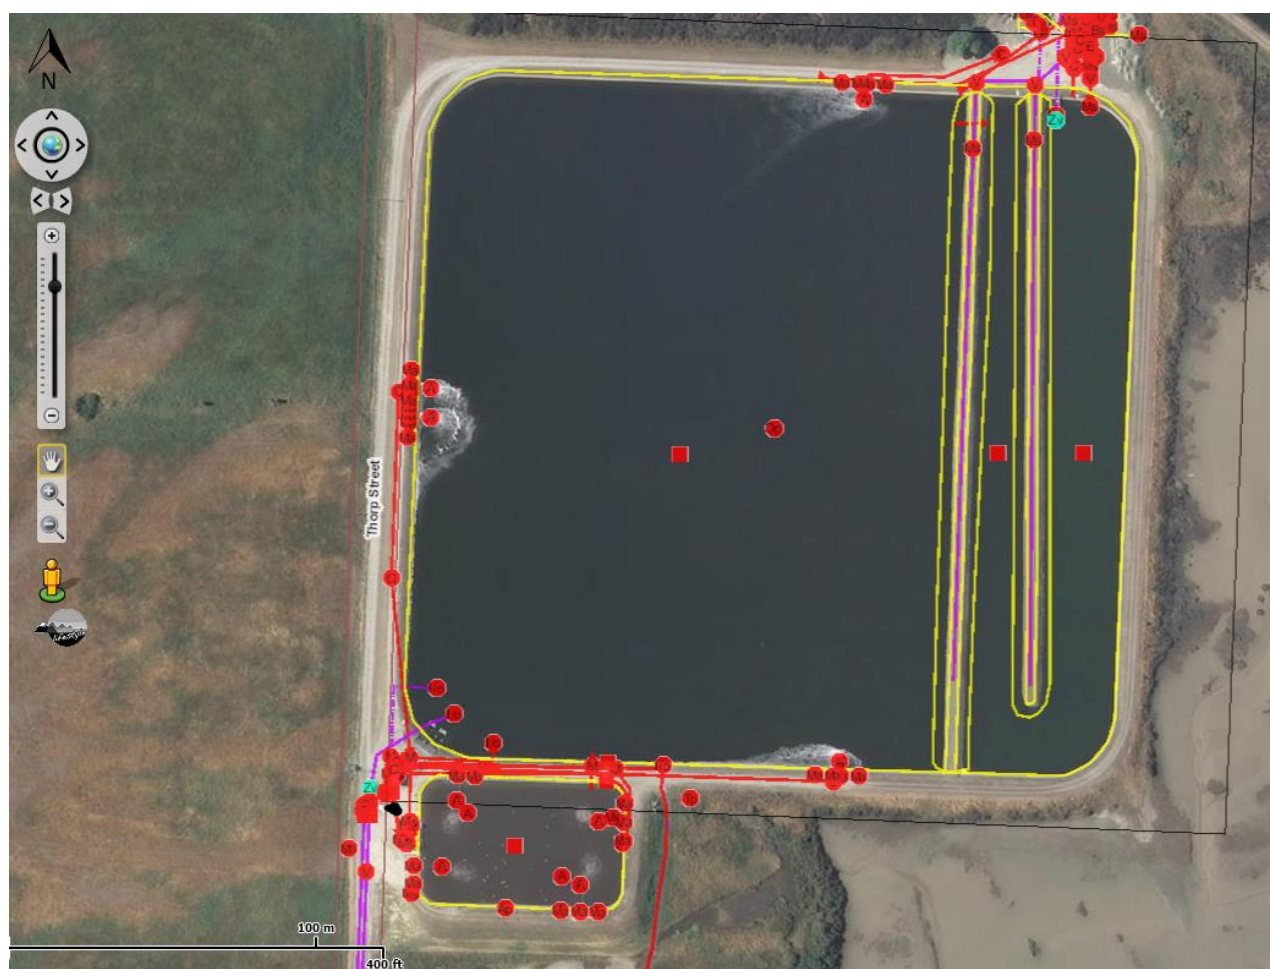
Construction contractors undertaking work at the inlet end of the Motueka Wastewater treatment plant damaged a rising main pipe line, causing wastewater to flow into the excavation trench. The approximate break location is shown by the black dot in the lower left hand quadrant of the picture below

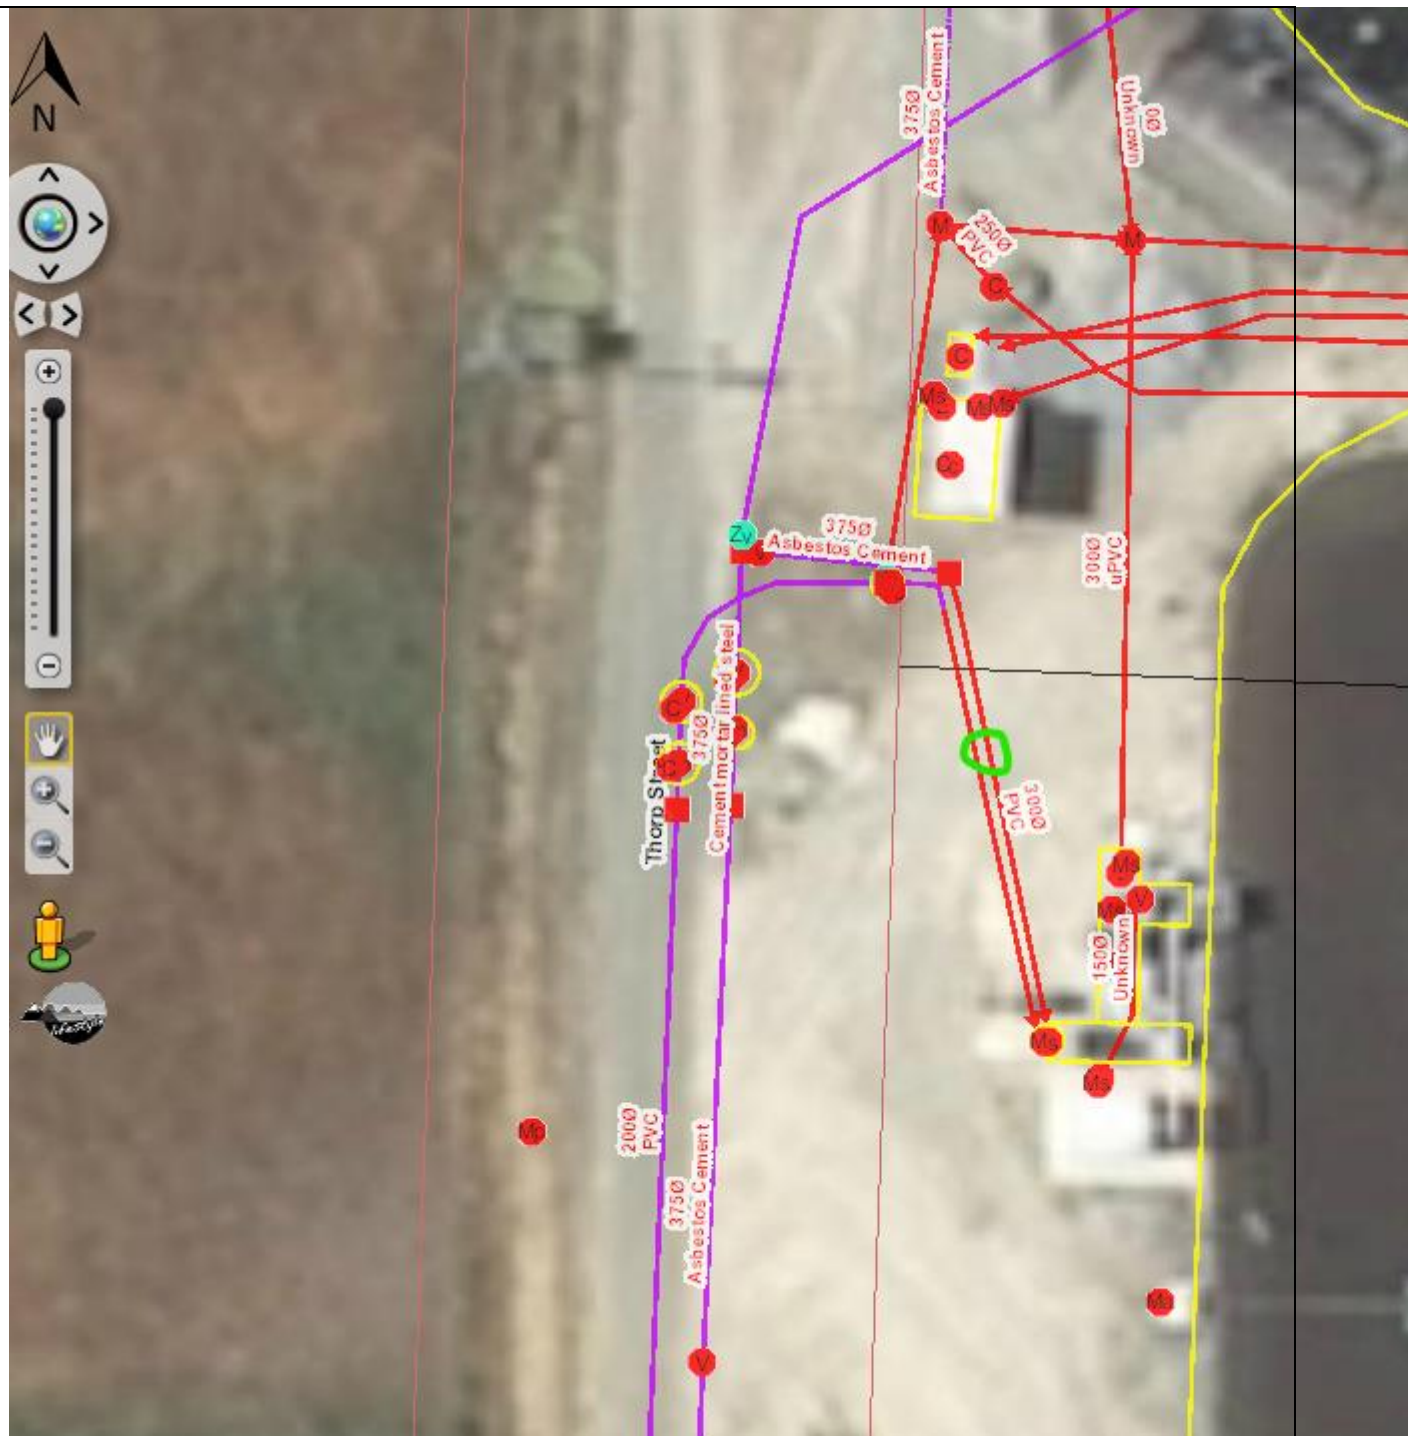
They immediately notified our operations contractors, who switched off the upstream pump stations and organised for wastewater to be trucked from these to the treatment plant.

The construction contractors put a transfer pump into the trench and pumped the majority of the wastewater back into the aeration pond. A small quantity of wastewater will have got into the groundwater.

The damaged section of pipework was repaired by 16:30
