Council Sewage Spill Notification Form to the PHS (Block A)

Location and Cause: (Council may embed a map in this section or attach to email when form notified to the PHS)

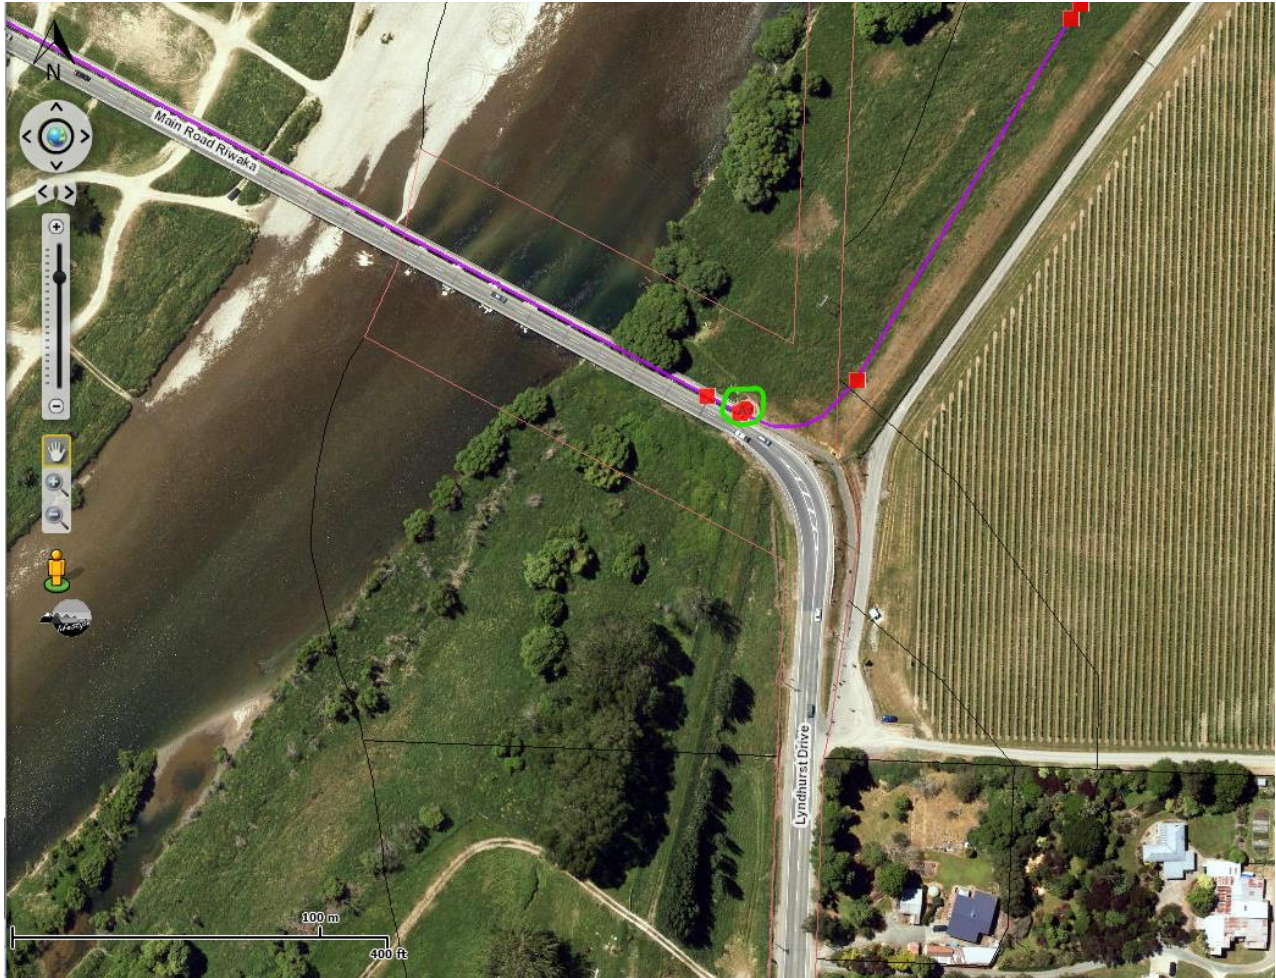
A section of air valve piping, connected to the Riwaka sewer rising main, has rusted through. This resulted in a wastewater leak whenever the main Riwaka pumps sewer pumps were turned on.

The maximum duration of the leak is 9 days, but could be considerably less. It is quite possible the break was caused during the yesterday's repair work at the inlet section of the Motueka wastewater treatment plant.

It is unlikely that the leak has reached the river, some wastewater has pooled at the bottom of the bank below the air valve.

The section of pipe has been isolated from the rising main and will be repaired.

The leak area has been cleaned.

<p>Summary of any risk mitigation action to be taken by Council (Council to complete) Block B</p> <p>Council may complete this block at the same time it completes Block A or subsequently following discussions with the PHS in the case of more complex spills.</p> <p>This pipe appeared to be defective, it was relatively new and should not have failed. There is not much more that could be done to prevent this type of failure.</p>
--
